SUCCESS AND SUCCESSION

Terry McGlade, Jenny Hill

Flynn Canada/University of Toronto

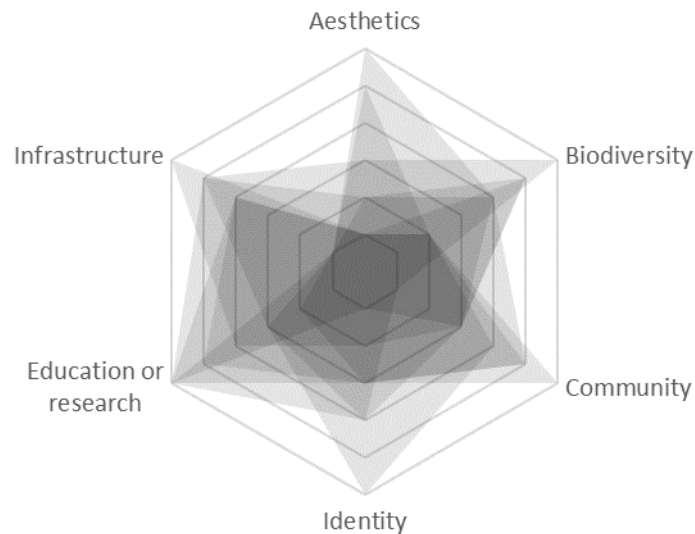
Figure 1 Stakeholder rankings of the importance of green roof functions (n=7).

Question 1 established that three of eight respondents have been with their organization since their roof was constructed and three have joined their organizations since. Four respondents identified themselves as responsible for the upkeep and maintenance of their roof. Question 2 results regarding the importance of various factors, are presented below in Figure 1. In each respondent's polygon, more important functions project further from the centre. Based on mean rankings the key priority was education and research, whilst the lowest average ranking was given to aesthetics. Half of the respondents said that their roof was 'successful' and selected 'somewhat' to this question. Frustrations were expressed about limited accessibility and use of roofs, particularly for educational purposes. This directly reflects the nature and priorities of the organizations. Another comment was made regarding the Toronto bylaw and questioned the effectiveness of green roofs from a sustainability perspective. No concerns were expressed about the upkeep or evolution of their green roof design over time.

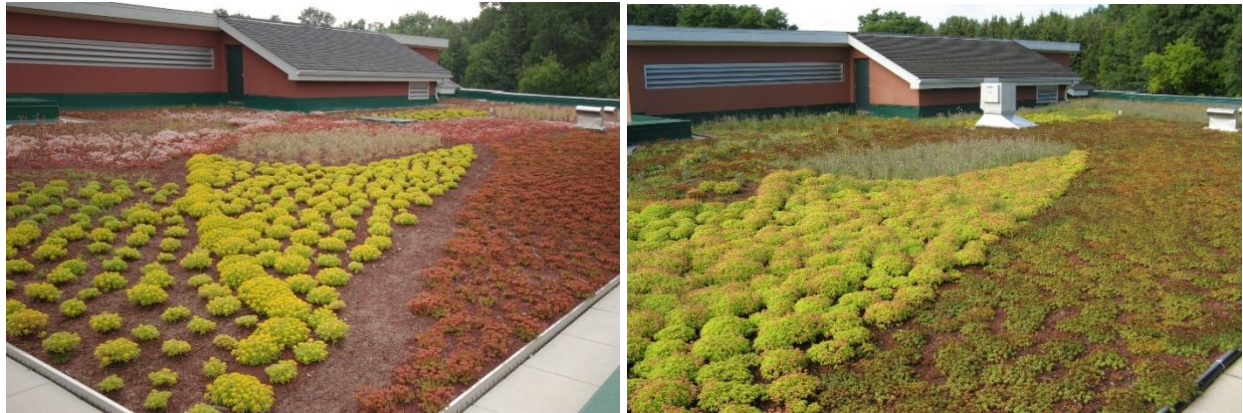
Figure 2 Earth Rangers Southern roof: 2005, after 2 years establishment (left), and 2013 (right).

This green roof was originally commissioned with a strong interest in the infrastructural benefits in terms of storm water retention and moderating the temperature within the building envelope. Despite these primary motivations, the roof is overlooked from the building's upper storey and is one of the most highly maintained roofs studied. Monthly weeding and occasional manual irrigation results in the visible retention of the geometric design over ten years later (Figure 2). The Southern green roof (pictured) is the most 'traditional' of the study installations, comprising Sedum species planted into a low organic medium. Eight Sedum species were planted with Chives (*Allium schoenoprasum*) and White Clover (*Trifolium repens*) providing additional height and texture. Originally this design spanned three roofs; north, east, and south over the first floor wings of the buildings.

After six years, this system had not developed significantly and lacked the dynamism that the owners wanted to promote green technology awareness and to integrate the roof into the natural surroundings. So the Eastern roof was replaced in 2010 to support a variety of native and ornamental perennials in a substrate with higher % compost. Due to the maintenance, this roof has also remained largely unchanged since installation although some areas of geraniums (*Geranium maculatum*) and all of the Tickseed (*Coreopsis* sp.) were lost in the winter 2013/2014. In the winter of 2013/2014 a weir was installed to measure the output flow from the entire green roof (South-East and a North wing). This is the final data stream for the building owners, Earth Rangers, to track their entire water balance (both indoor and outdoor uses) on a continuous basis.

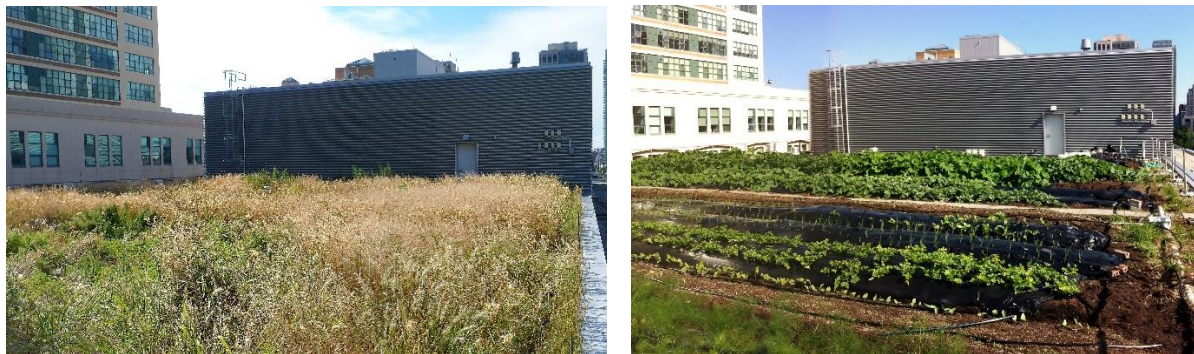
Figure 3 George Vari Engineering Building roof, 2013 (left), and 2014 (right)

In contrast, the green roof of the George Vari Engineering building at Ryerson University was originally conceived as a monoculture of daylilies (*Hemerocallis* 'Catherine woodbury') and was equipped from the outset with a suite of hydrological and climatological sensors for research purposes. This roof received minimal maintenance for over eight years, with just woody species being removed to prevent membrane damage. For many years there was no irrigation system installed.

After just four years the number of species had risen to thirty-nine, as many volunteer species colonized (5). Some *Hemerocallis* remain still in 2014, although, until 2013, this urban ecosystem continued to evolve into more of a prairie meadow with *Aster* sp., *Asclepias tuberosa*, *Linaria vulgaris* and *Vicia cracca* prevalent amongst the grasses. A dramatic change in the management of this roof occurred between 2013 and 2014, as a group of community gardeners took control of the space and turned much of the area to vegetable production (Figure 3). With this new function the space is accessed twice per week through the summer months and now receives automatic irrigation and regular soil amendments in addition to weeding care.

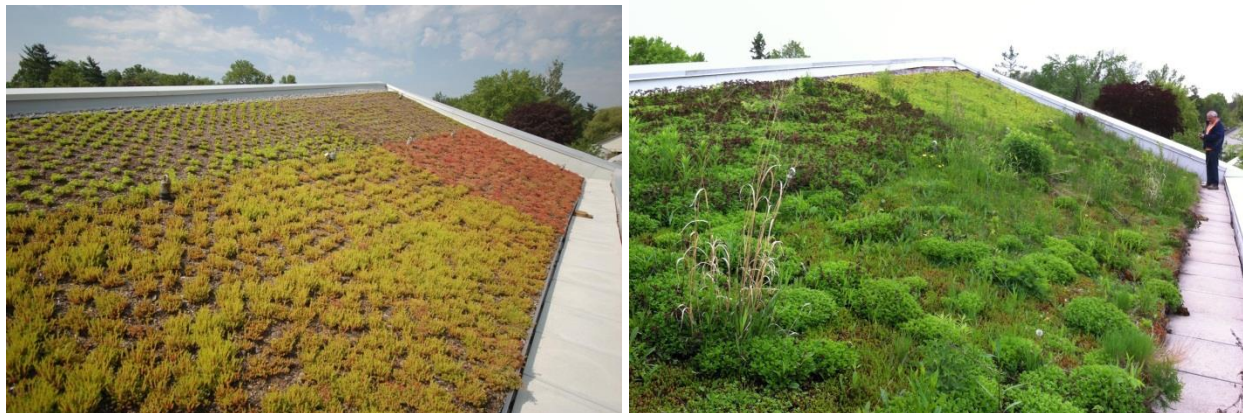
Figure 4 Toronto Botanical Garden sloped section, 2006 (left) and 2014 (right).

This roof, of two parts, was intended to fit within the overall botanical garden theme of a curated garden landscape. The largest part of the roof (60 m²) is sloped to the north on a curve, from 22 to 30°. This area has battens to retain the planting substrate and was planted with four varieties of Sedum. The slope restricts maintenance, as access requires the use of harnesses and steel lines to climb the loose surface (Figure 4). Although this is the second Sedum roof examined, the slope, the composition of the original planting substrate (high compost content), lower maintenance and higher vegetation coverage have led to a very different outcome. A thick layer of haircap moss (~10 cm) has formed an understory, resulting in a wetter environment at the substrate surface which supports fruiting fungi in the late summer.

The local seed bank is diverse and ornamental compared to other green roofs, leading to the establishment of Penstemon, Coneflower (*Ratibida pinnata*), Jerusalem Sage (*Phlomis tuberosa* 'Amazona') in addition to the more common Golden rod (*Solidago* sp.) and the seemingly ubiquitous Black medic (*Medicago lupulina*).

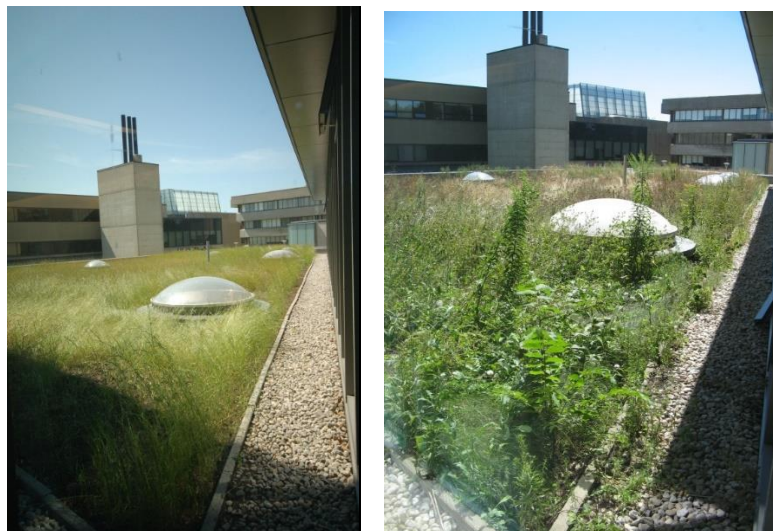
The system is still dominated by the rye grass with other abundant species including yarrow (*Achillea millefolium*) dog strangling vine (*Cynanchum rossicum*) (Figure 5).

Figure 5 Arts and Administration green roof, University of Toronto, 2005 (left) and 2013 (right).

Installed at the time of the building construction, this roof was originally seeded with a wildflower mixture, with a nurse crop of Annual Rye (*Lolium multiflorum*). The clients were clear that they required a minimal maintenance system and did not provide irrigation beyond the first season.

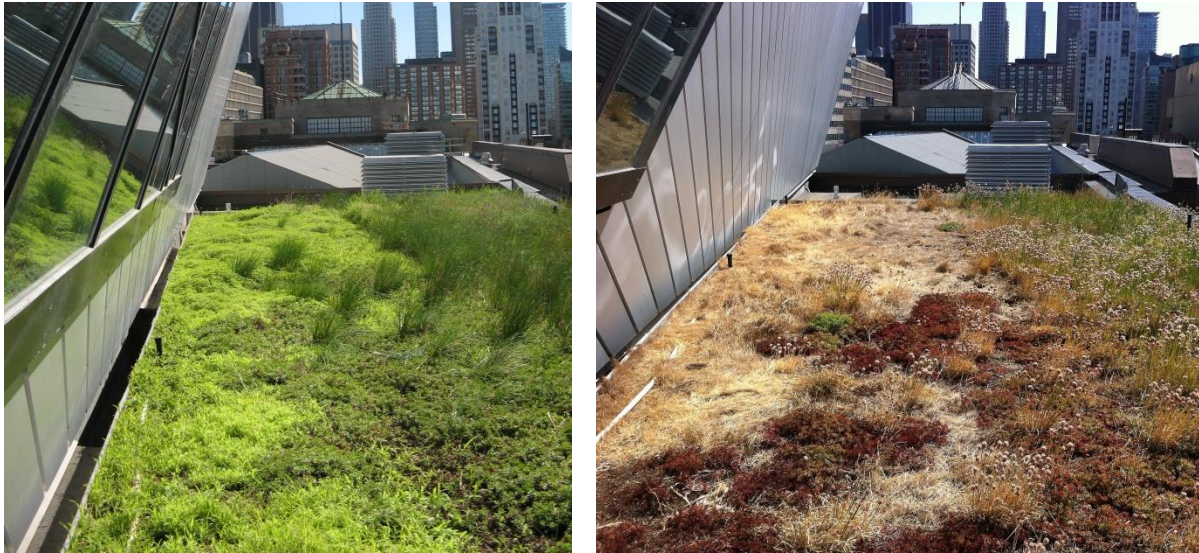
Although one of the youngest roofs studied, this green roof (519 m²) has a number of remarkable features. It is located to the South of an overhanging reflective aluminium fascia, which results in a very hot dry area directly alongside the only observation point, a restaurant window. The majority of the installation is suspended 1.2 m above the existing roof with deeper recesses to support ornamental trees. The original planting comprised Sedums – 8 main varieties with about 16 different cultivars, and Hens and Chicks (*Sempivivum* sp.), chives and horsetail grass (*Equisetum* sp.). The spray irrigation system is programmed to deliver twice a day during the summer due of the low storage volume of the planting substrate depth. In the first two years there was an attempt to maintain the design intent with weeding and replacement of dead sedums. But with the spread of the chives and the horsetail grass into the highly designed sedum fields it was seen as an impossible maintenance endeavor and after the two year warranty period all routine attention ceased. Over time it has acquired a diverse look from the original highly stratified design of white, yellow and pink Sedum areas. The design intent was fraught with unrealistic expectations from the start – form beat function to the detriment of good horticultural practice or practicality. One area which suffered particularly is beneath the overhang, the intense heat and light eradicated the Hens and Chicks leaving an opening, which was occupied by Quick Weed (*Galinsoga quadriradiata*) in 2013. This is an annual weed, which failed to germinate by June 2014, resulting in the exposure and erosion of the planting substrate, and subsequent damage to the irrigation line, exacerbating the problems (Figure 6).

Figure 6 Royal Ontario Museum scorched section detail, 2013 (left) and 2014 (right)

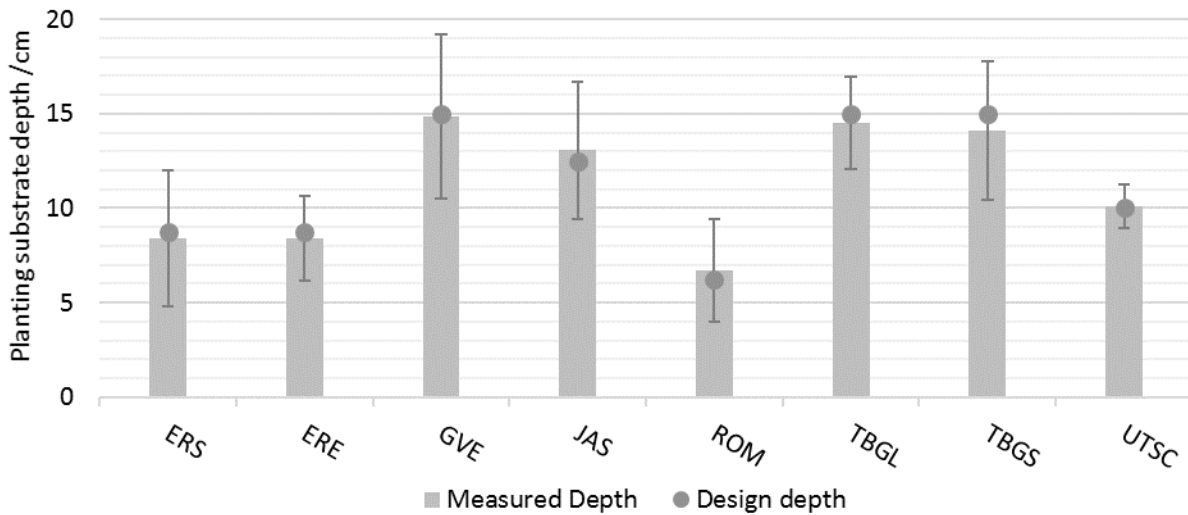
Based on the depth measurements, none of the planting substrates have demonstrated significant bulk compaction since installation (Figure 7).

Figure 7 Depth of planting substrate on eight green roofs
