Differential Durability, Building Life Cycle and Sustainability

Ted Kesik

Faculty of Architecture, Landscape, and Design
University of Toronto

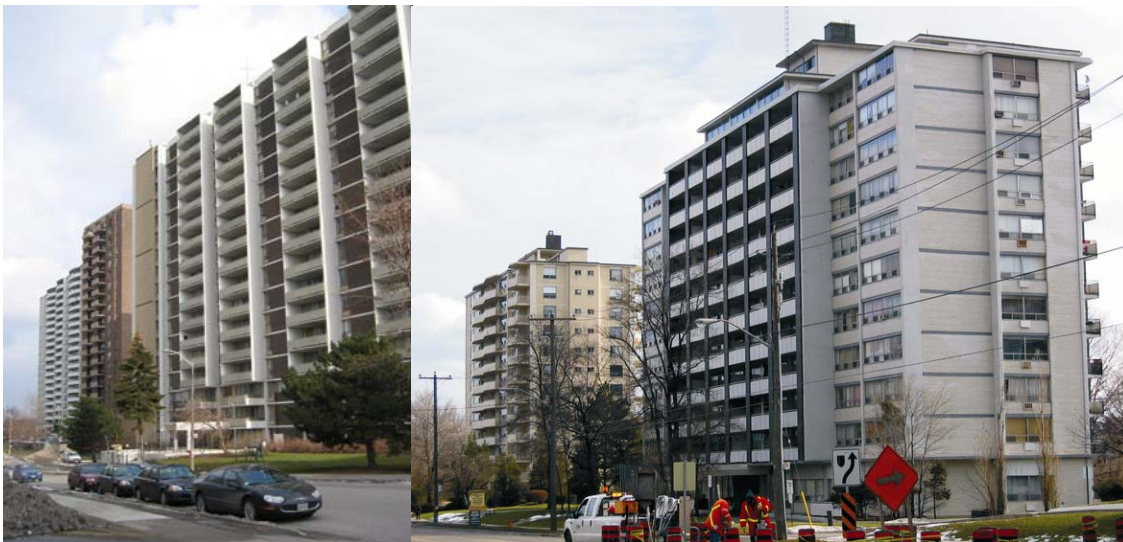
FIGURE 1

These high-rise apartment buildings located in Toronto, Ontario are typical of this extensive form of housing stock constructed predominantly during the 1960s and 1970s in Canada.

A vast majority of high-rise housing constitutes rental housing predating the condominium form of tenure. The structural system employed was steel reinforced cast-in-place concrete arranged in a series of parallel shear walls including end walls, some of which were clad in brick veneer. Spanning perpendicular to the shear walls were one-way steel reinforced cast-in-place concrete floor slabs. This seemed to be in keeping with the arrival and development of flying form technology. Roofscapes indicated poured concrete elevator cores and stairwells. Later versions of the typology began to articulate the end walls with more punched openings. Earlier, lower-rise versions utilized poured columns and beams often displaying corner windows. Contemporary versions tended to display a hybrid system of shear walls throughout the body of the building and flat plate slabs with concrete columns at the ends providing opportunities for corner and end wall glazing.

The predominant form seemed to be linear buildings, followed by “Y” shaped and point towers. No matter what the plan geometry, all forms displayed common structural and envelope characteristics. The predominant envelope system was 100 mm (4”) brick veneer with a 100 mm (4”) concrete block back-up tied together by a regular rhythm of continuous header courses, an early version of mesh reinforced interior gypsum board on wood strapping and plaster with oil based paint finish. The solid non-load bearing masonry envelope more often than not simply sat on top of the exposed exterior floor slab perimeter

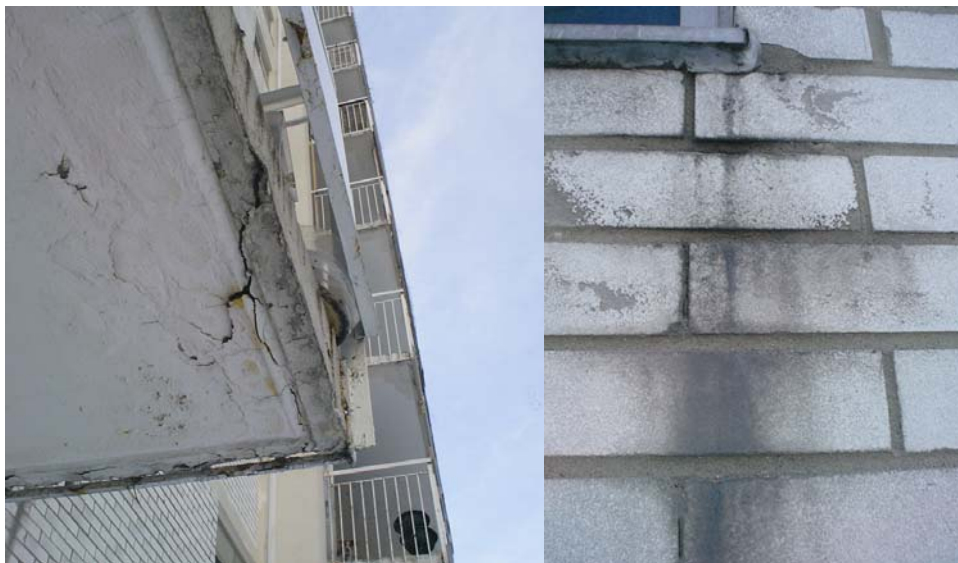
FIGURE 2

Defects in high-rise housing range from structural problems to cosmetic staining. Cantilevered balconies enhance amenity but cause thermal bridging and are highly susceptible to deterioration – yet they represent enormous potential for innovative envelope retrofit strategies. This feature has become notably absent in contemporary condominium tower designs.

Balconies in general represented a location where deterioration was evident. The junctures of steel balcony guards and slabs usually required immediate attention and often displayed exposed and corroded anchors and deteriorating concrete. The underside of said balconies often displayed surface and finish deterioration. Drip edges were inadequate or had been compromised by successive finish applications. Corrosion was also often evident wherever painted steel balcony guards had been employed.

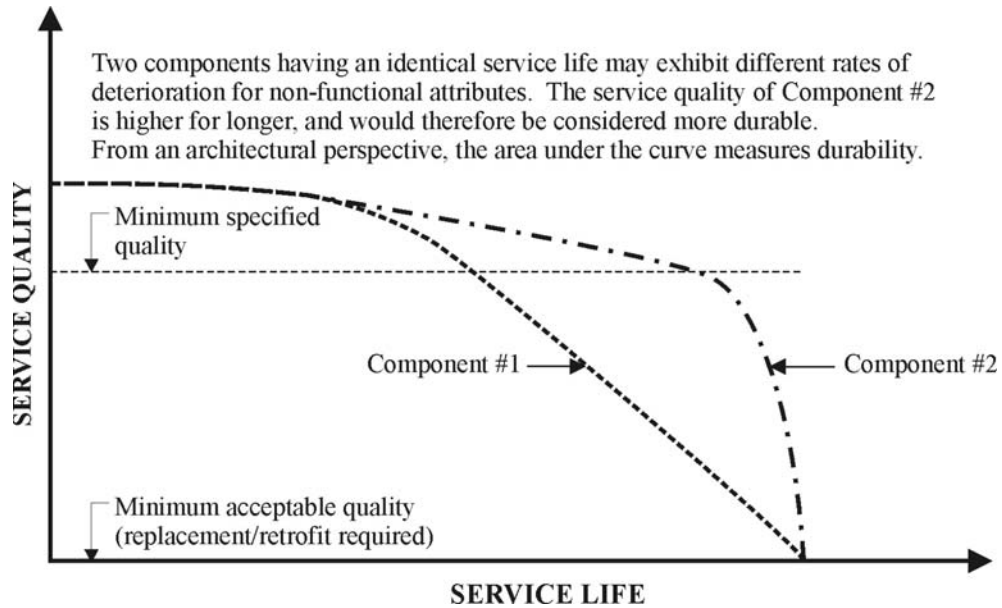
FIGURE 3
Service Quality X Service Life = Durability

An important term that is often absent in durability literature is service quality. This term goes beyond the purely functional performance of a product, component, assembly or construction to include attributes such as aesthetics. For example, two different roofing materials may have an identical service life, but exhibit different visual deterioration. One may appear unsightly after a fraction of its service life has expired, while the other may preserve its appearance until only a few years before becoming unserviceable. Functionally both keep out the water for as long a period of time, but the service quality of the latter is higher for longer, as depicted in Figure 3.

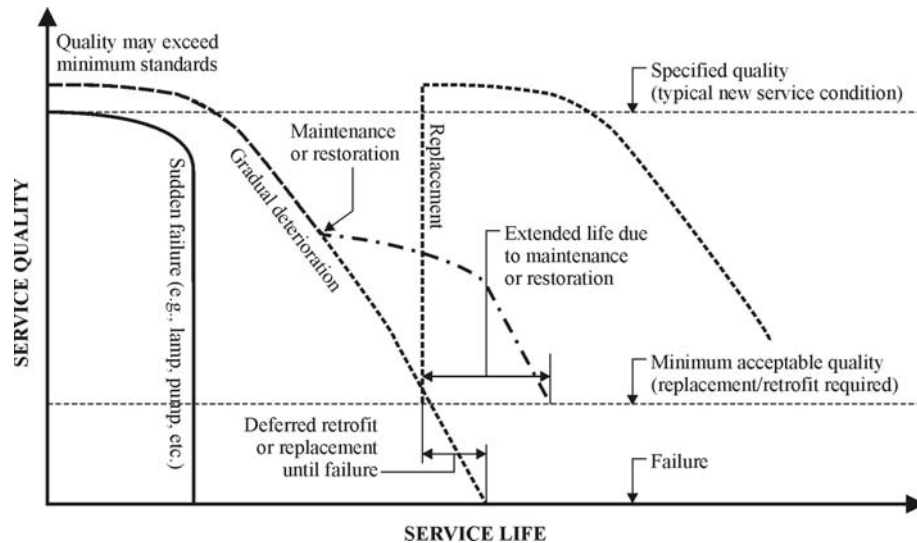
FIGURE 4
Durability characteristics and relationships as a function of service quality and service life.

Figure 4 depicts the key characteristics and relationships associated with differential durability concepts. As discussed earlier, durability may be expressed as a function of service quality and service life. There are three critical service quality thresholds related to durability: 1) the specified quality, established by the designer and/or minimum codes and standards, representing the typical new service condition; 2) the minimum acceptable quality indicating the need for replacement or retrofit; and 3) failure, where the material or assembly is considered completely unserviceable.

Failure may occur suddenly, as in the case of a lamp, pump or similar type of equipment, or it may result after gradual deterioration. Maintenance or restoration taking place prior to failure can extend the service life, whereas deferred retrofit or replacement beyond the minimum acceptable quality threshold can accelerate total failure. It is important to note that in some cases, the initial service quality of the material or assembly may exceed the specified quality based on codes and standards.
